Docket No. 217 – Development and Management Plan Inspection

Northeast Utilities Service Company Certificate of Environmental Compatibility and Public Need for the construction of a 345-kV electric transmission line and reconstruction of an existing 115-kV electric transmission line between Connecticut Light and Power Company's Plumtree Substation in Bethel, through the towns of Redding, Weston, and Wilton, and to the Norwalk Substation in Norwalk, Connecticut.

Date: February 16, 2006

Location: 115 kV Underground Route

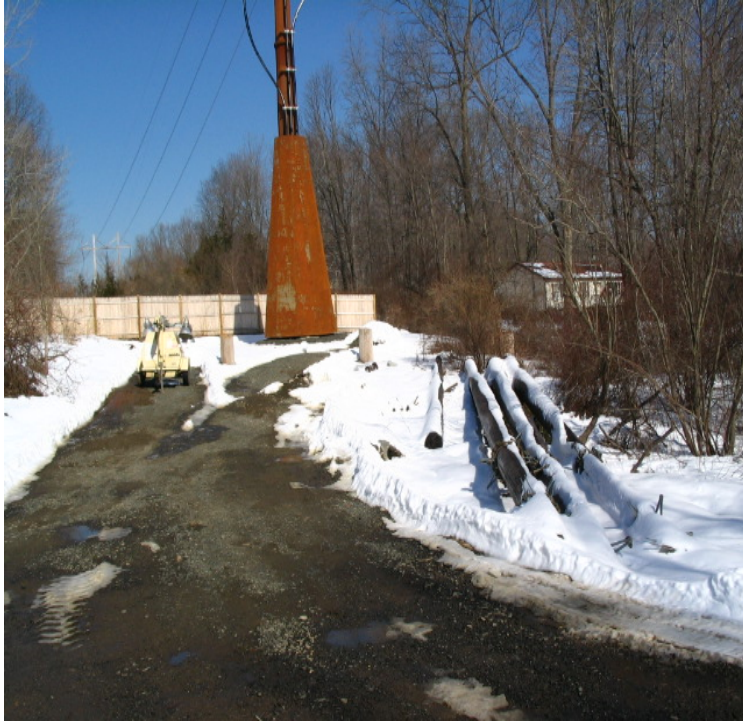
115kV (ROW and Hoyts Hill): Photo on the left shows the tower at Hoyts Hill. Some minor cleanup is needed here with small bungee cords on the ground. Photo on the right shows the northern tower at Bethel Ed. Park. Washouts could not be checked due to snow cover. 2/16/06

- Hoyts Hill Transition Structure: No work at this time. 2/16/06	- General litter pickup/housekeeping is recommended. 2/16/06
Gallows Hill Road and Rt. 107, Redding	- The storage area near the Rt. 107 turn is in good shape. 2/16/06	- None at this time. 2/16/06
Rt. 58, Bethel	-The storage area at Sunset Hill Rd. remains in good shape. 2/16/06	- See additional sections for more information. 2/16/06
Broad Street/ROW, Norwalk	- A few materials were left behind along the side of Broad St. but most areas were mulched prior to snow cover. 12/22-2/16/06	-General cleanup should be performed and the road surface is still fairly rough. 12/14-2/16/06
Main Ave. / Rt. 7, Norwalk	-None at this time. 2/16/06	-None at this time. 2/16/06
Erosion and Sediment Controls	- The gully along the northern ROW continues to be present but snow cover prevented further observation. 2/16/06 - Sediment was also building up to the top of the silt fence near the north tower 2/16/06	-This gully has been placed with stone several times but continues to washout. Try larger stone or develop alternative solutions. 1/26-2/16/06 -The ROW needs restoration when feasible through the weather.

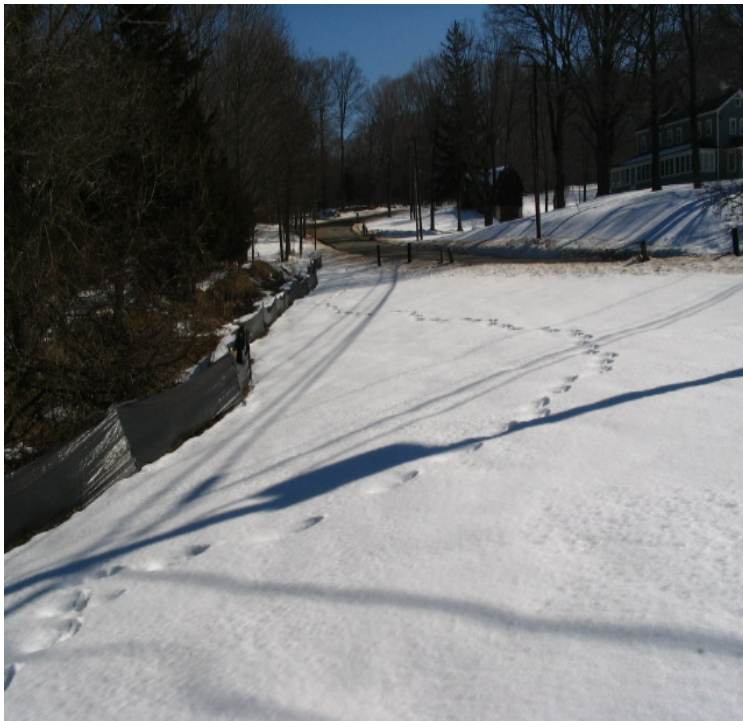
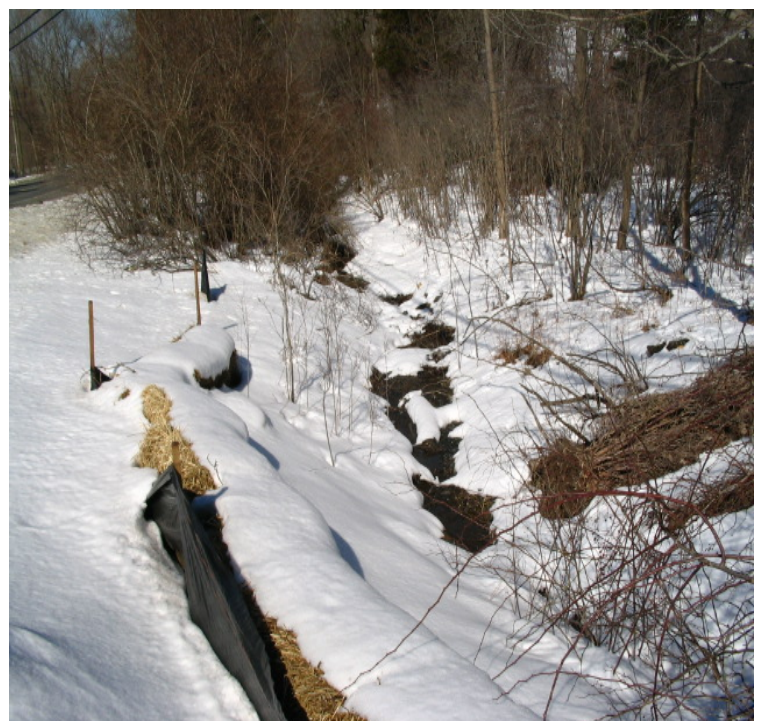
115kV (Rt. 58): Both photos show the Sunset Hill Rd. storage area with snow cover and erosion controls remaining well in place. 2/16/06
